Poznan University of Technology
Faculty of Mechanical Engineering

INVESTIGATION OF SUBSURFACE MICROCRACKS CAUSING PREMATURE FAILURE IN WIND TURBINE GEARBOX BEARINGS

A thesis submitted to Poznan University of Technology for the degree of Doctor
of Philosophy in the Faculty of Mechanical Engineering

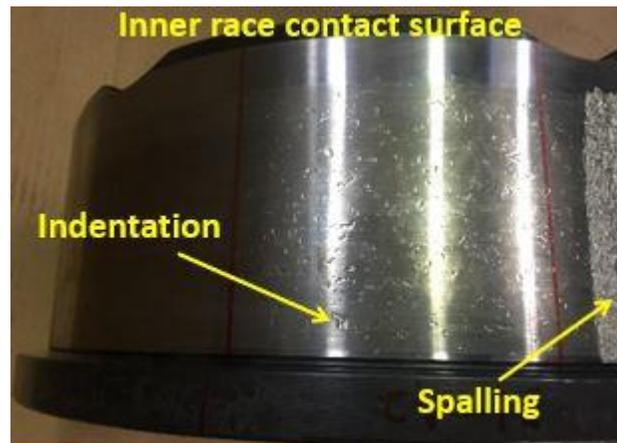
Figure 3-9: Surface indentation and spalling at the inner raceway of a roller bearing [the researcher]

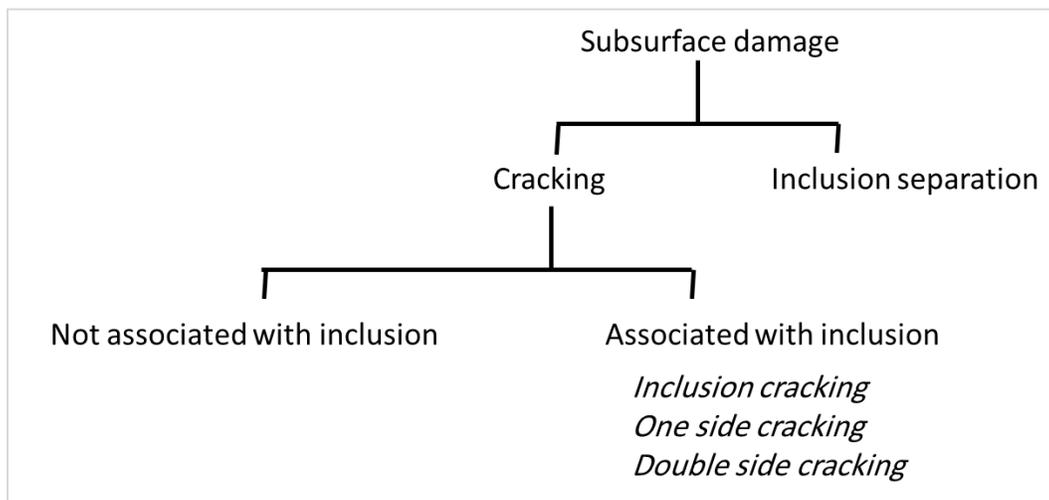
Figure 4-4: Subsurface damage types observed within the examined samples [247]

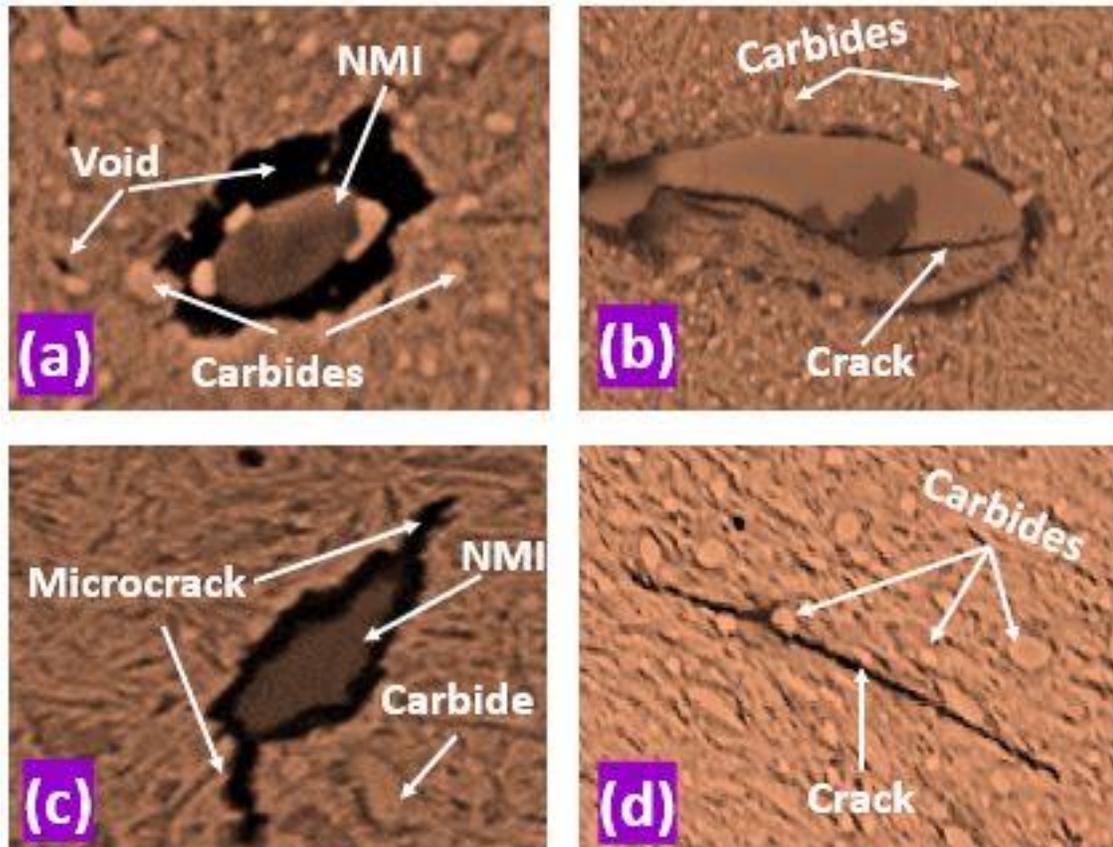
Figure 4-5: Samples of damage patterns observed, (a) non-cracked and separated inclusion; (b) self-cracking inclusion; (c) double crack associated with inclusion; and (d) crack not associated with inclusion [247]

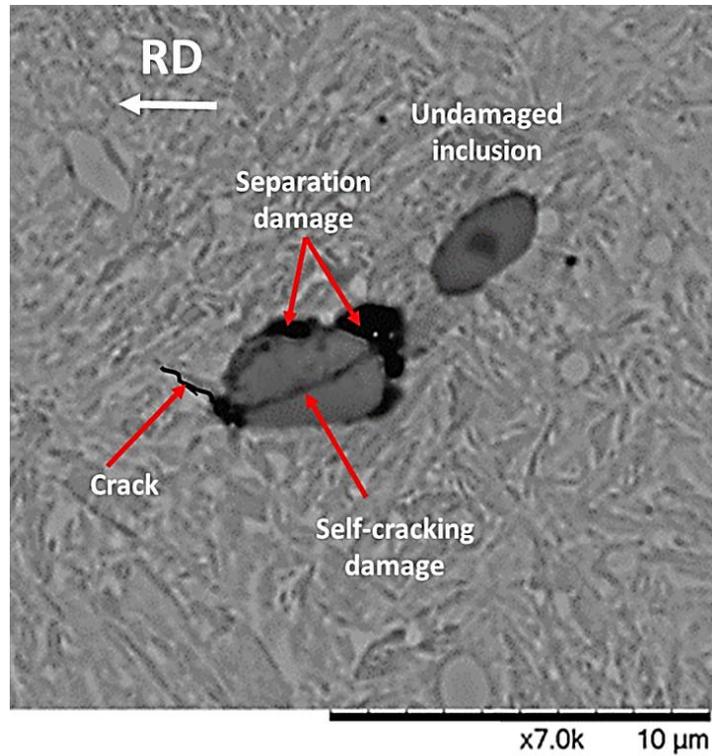
Figure 4-6: Mixed damage type associated with an inclusion [247]

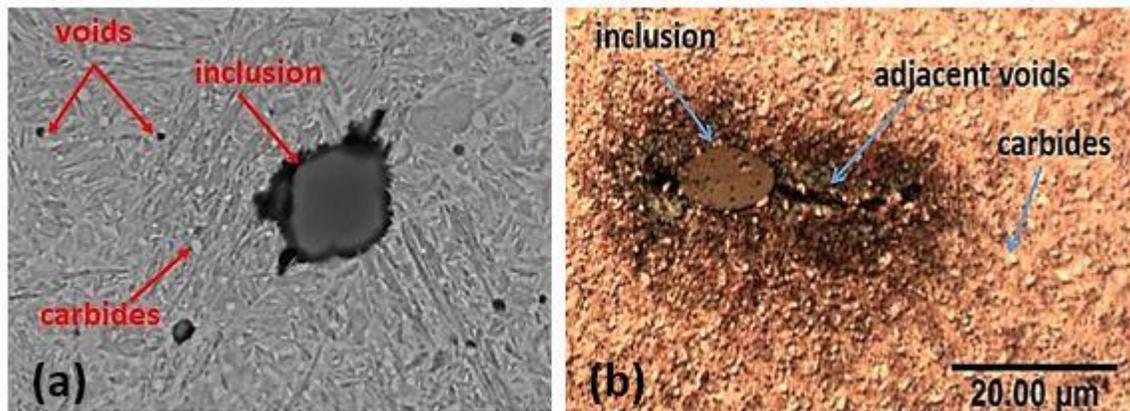
Figure 4-7: The voids and carbides impeded in the bearing subsurface region [247]

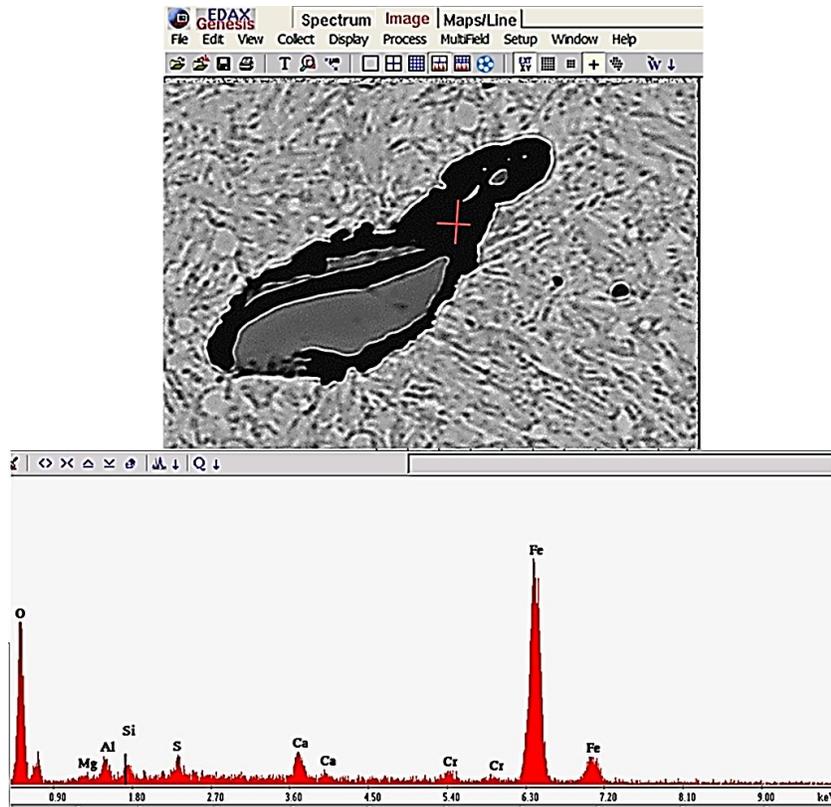
Figure 4-8: XRD analysis of separation area surround an inclusion [247]

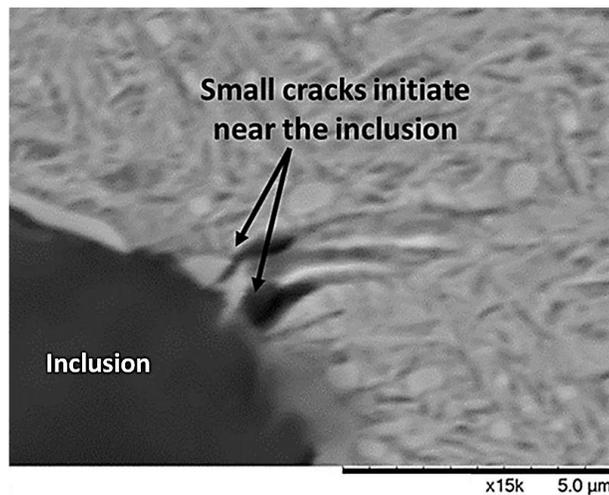
Figure 4-9: Cracks initiate close to the inclusion [247]

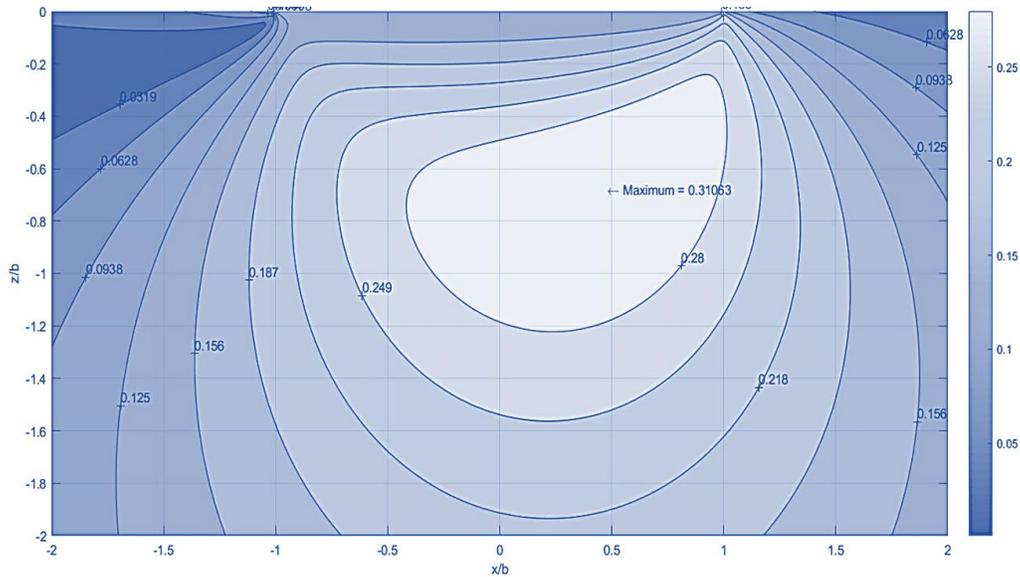
Figure 4-12: Effect of traction on subsurface maximum shear stress distribution ($\mu=0.15$) [247]

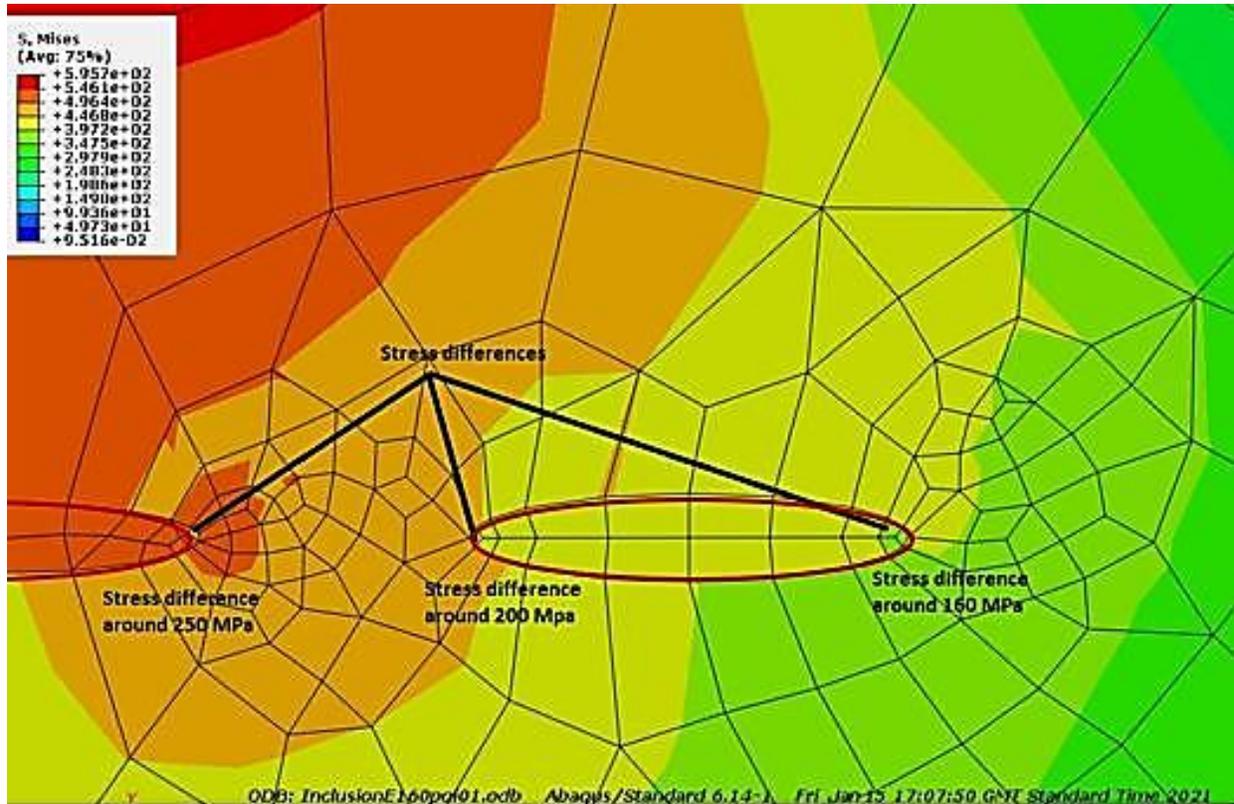
Figure 4-13: Difference in stress distribution for the non-metallic inclusions [247]

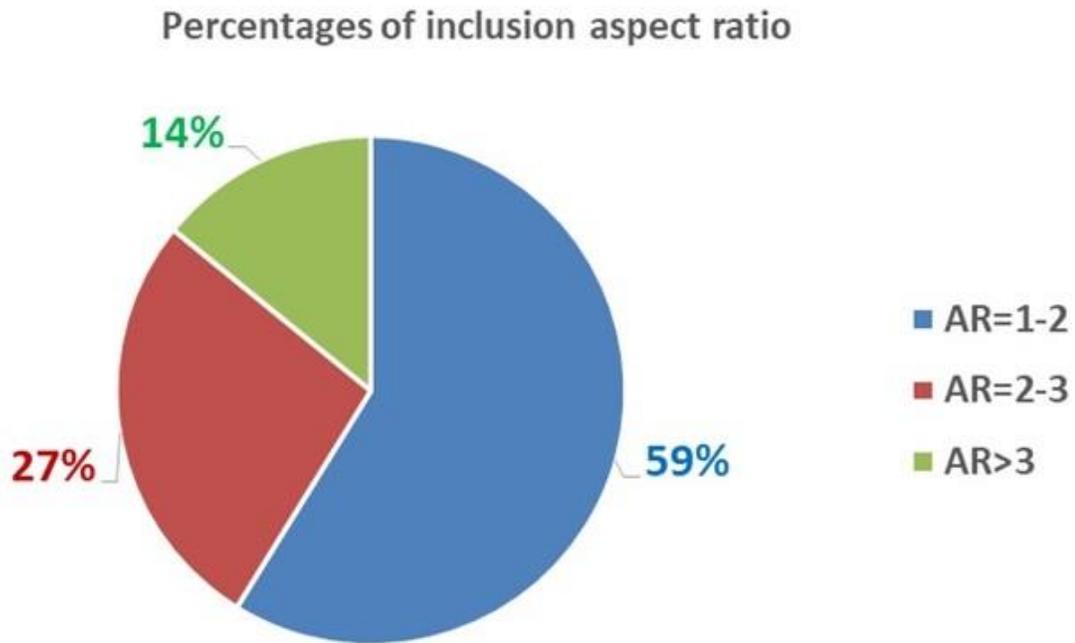
Figure 4-14: The percentages of the observed damaged inclusions and their Aspect Ratio [247]

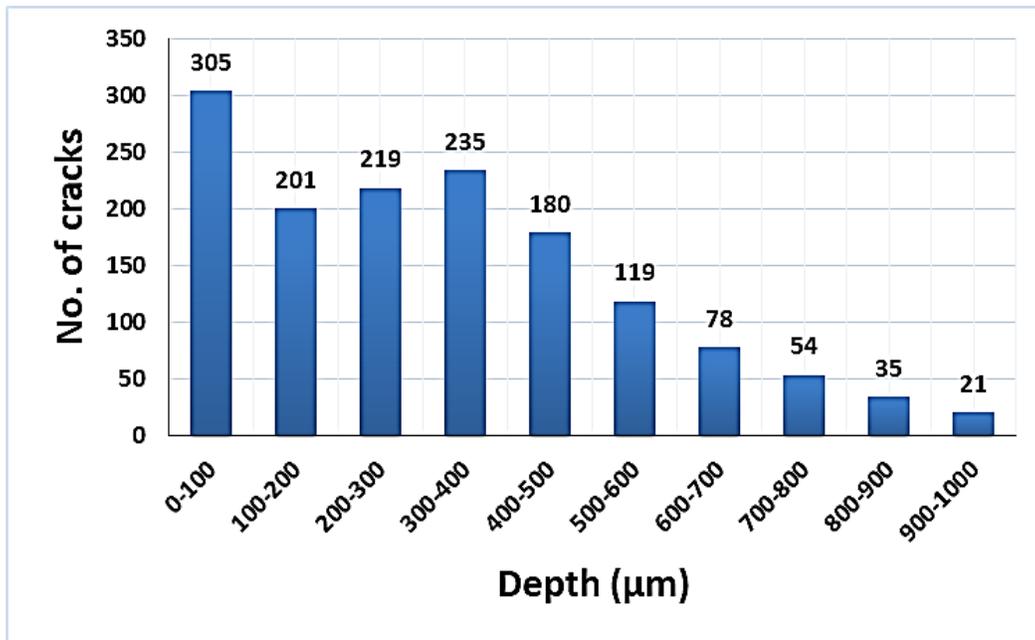
Figure 4-15: Distribution of the investigated small microcracks with depth [247]

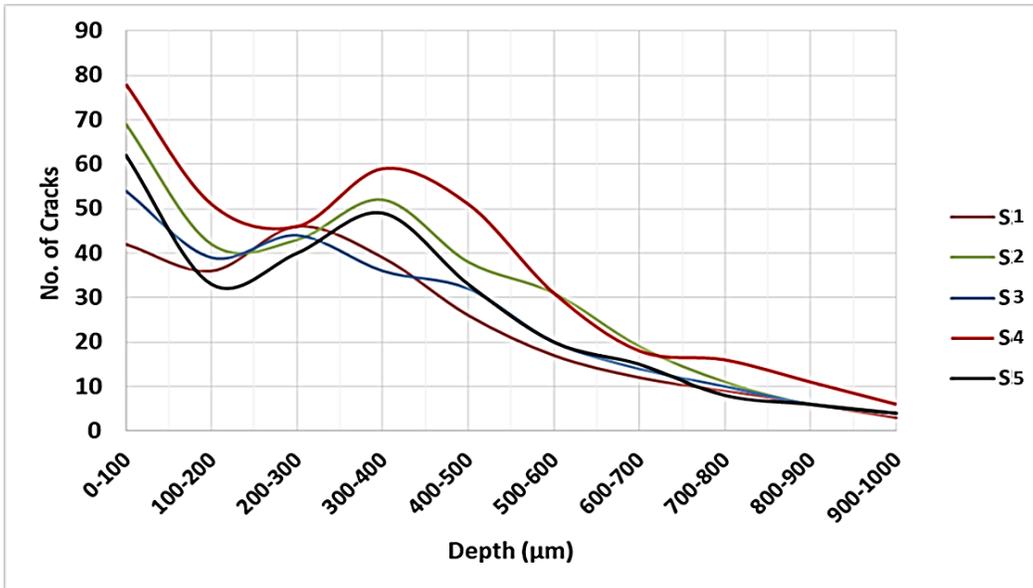
Figure 4-16: Crack density with depth of the examined samples [247]

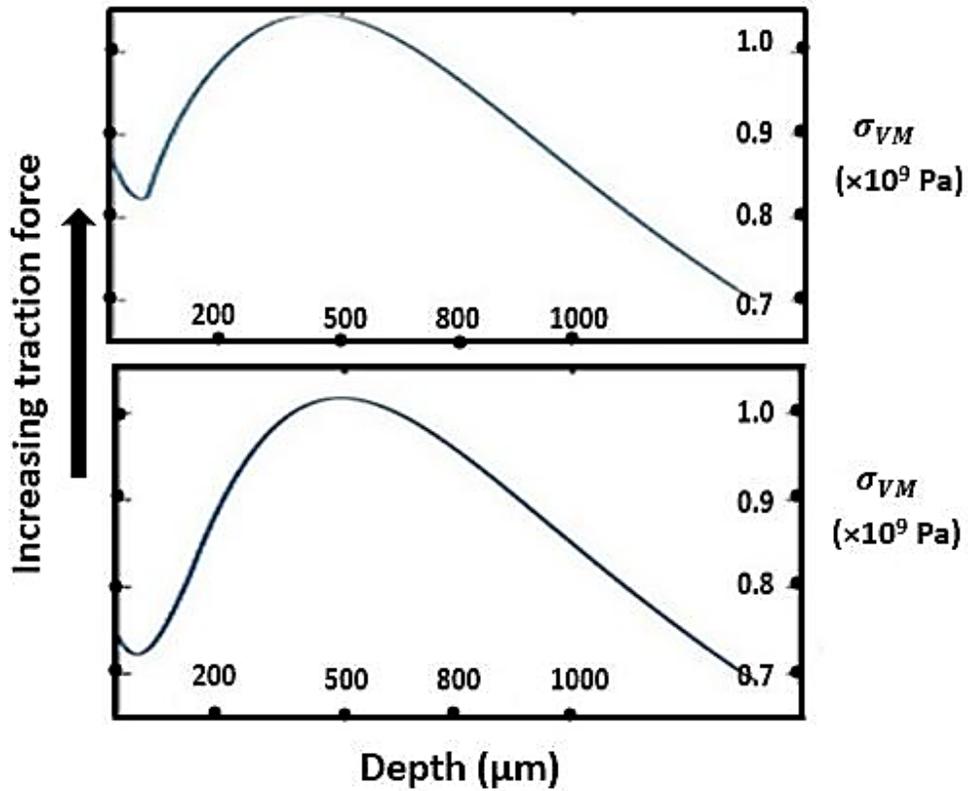
Figure 4-17: Simulating of Von-Mises stress with depth in terms of increasing the traction force [247]

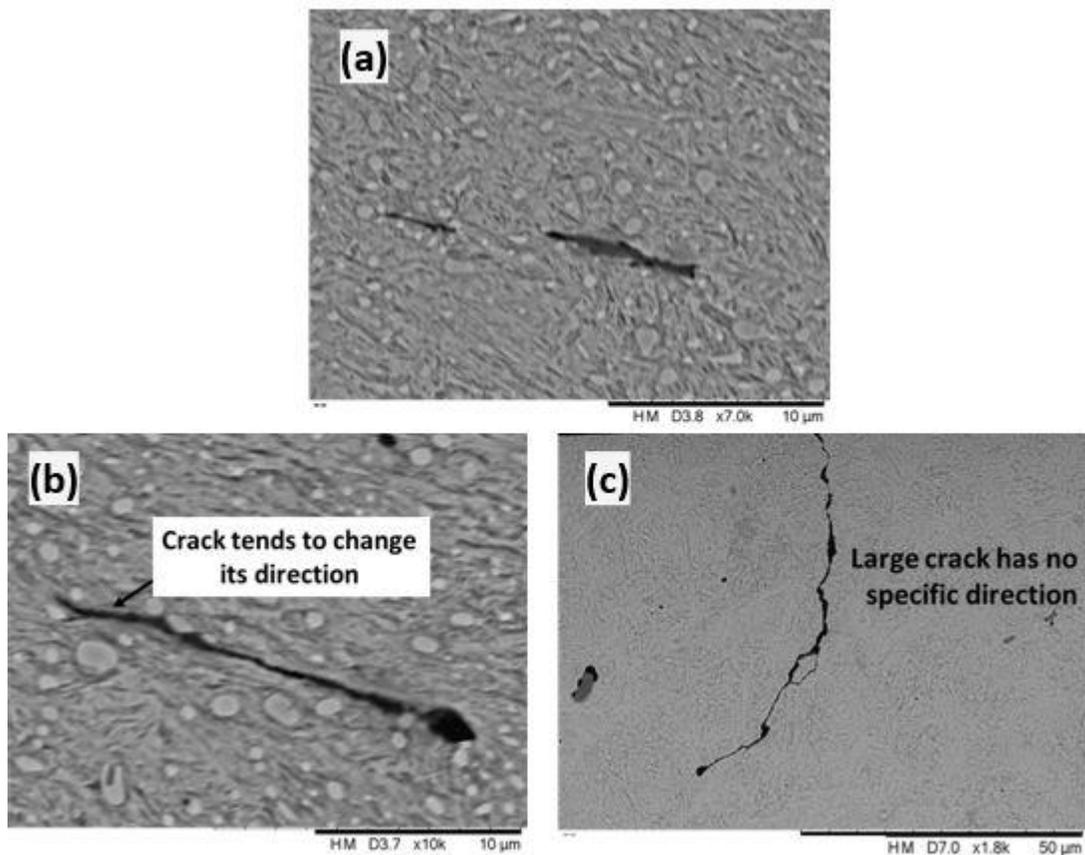
Figure 4-18: (a) Small straight cracks; (b)&(c) large kinked cracks [247]

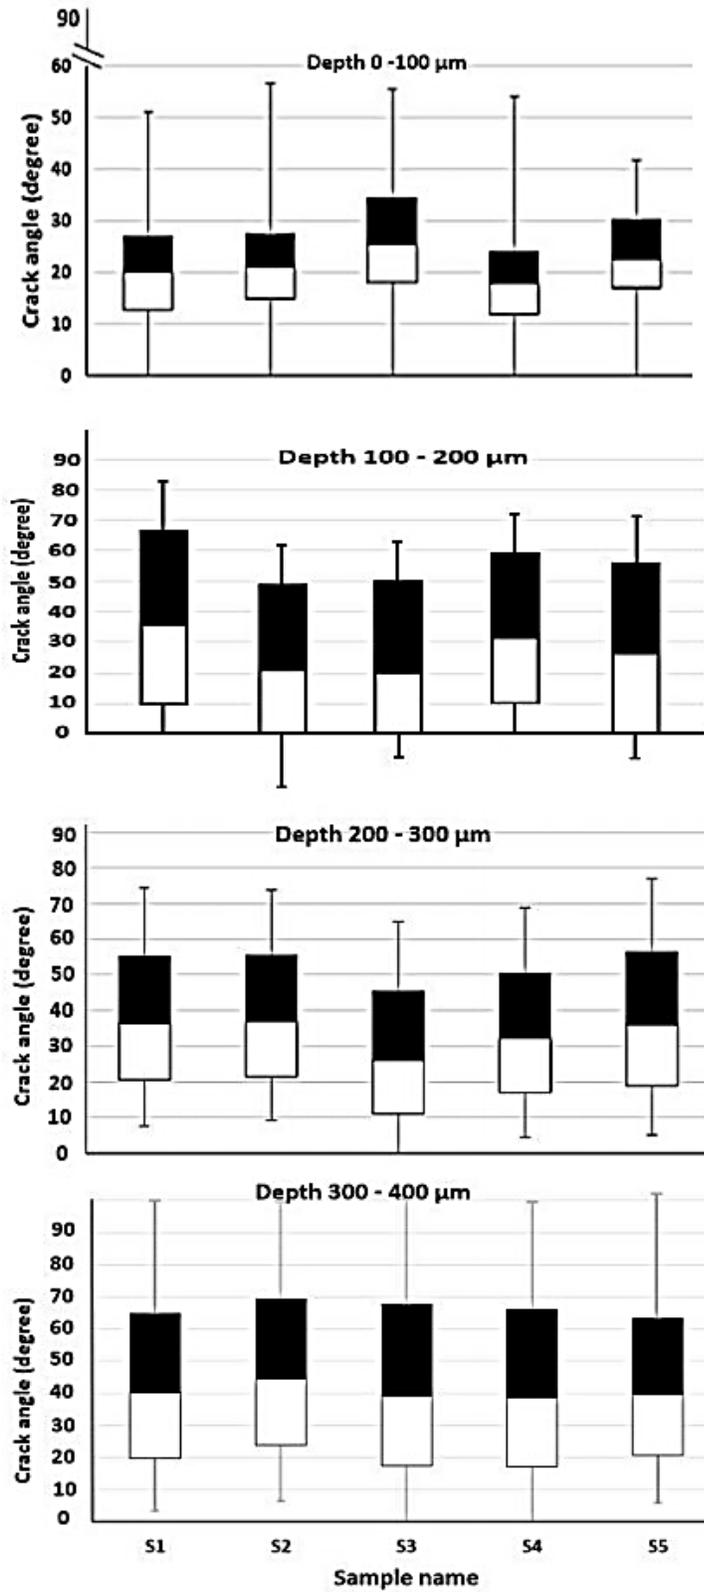
Figure 4-19 Characteristic of microcracks angles in shallow subsurface depths [247]

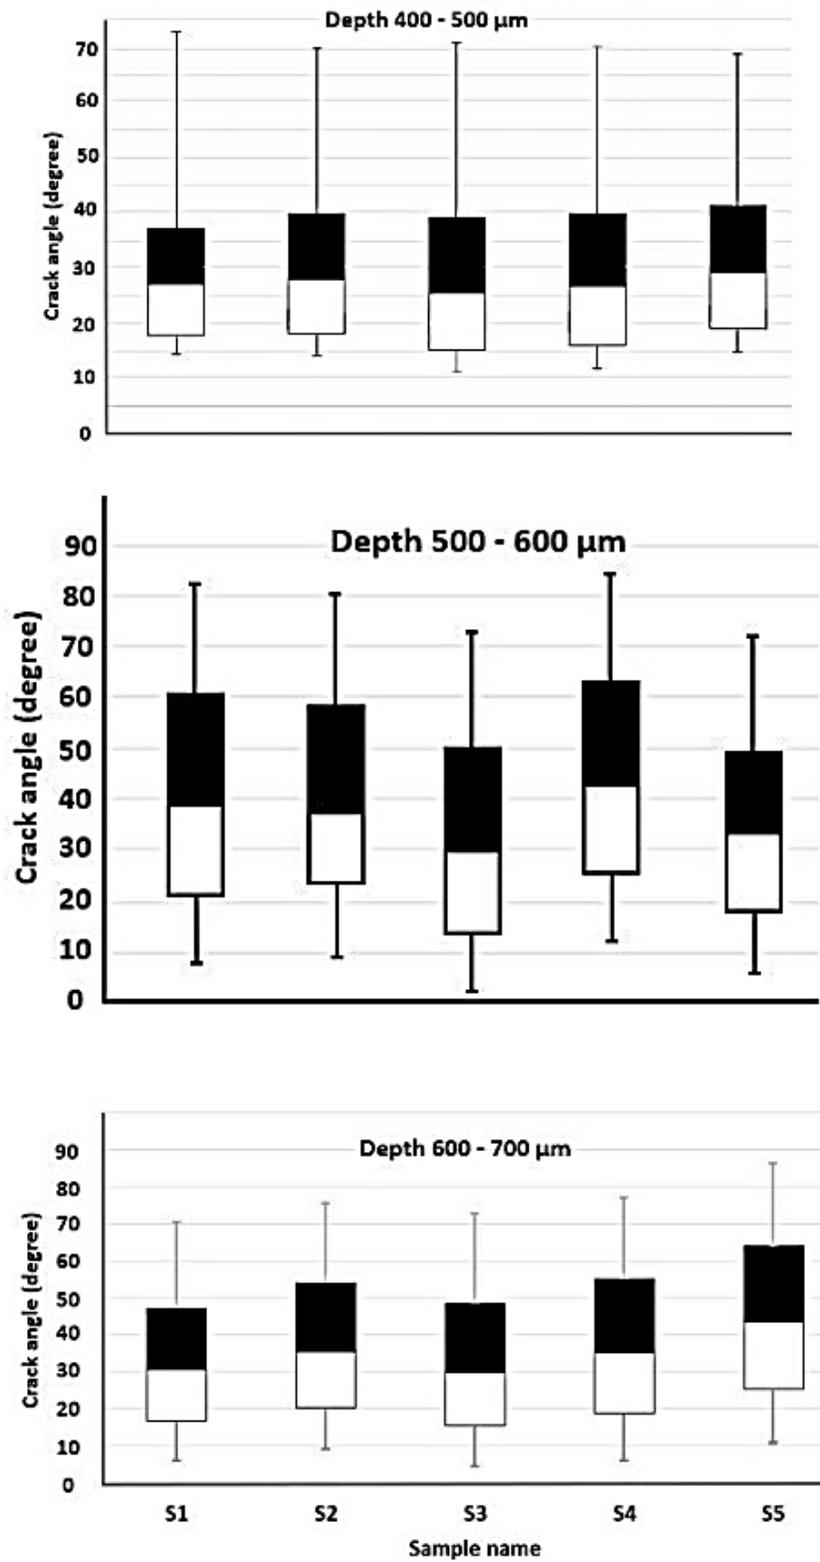
Figure 4-20: Characteristic of microcracks angles at deeper subsurface depths [247]

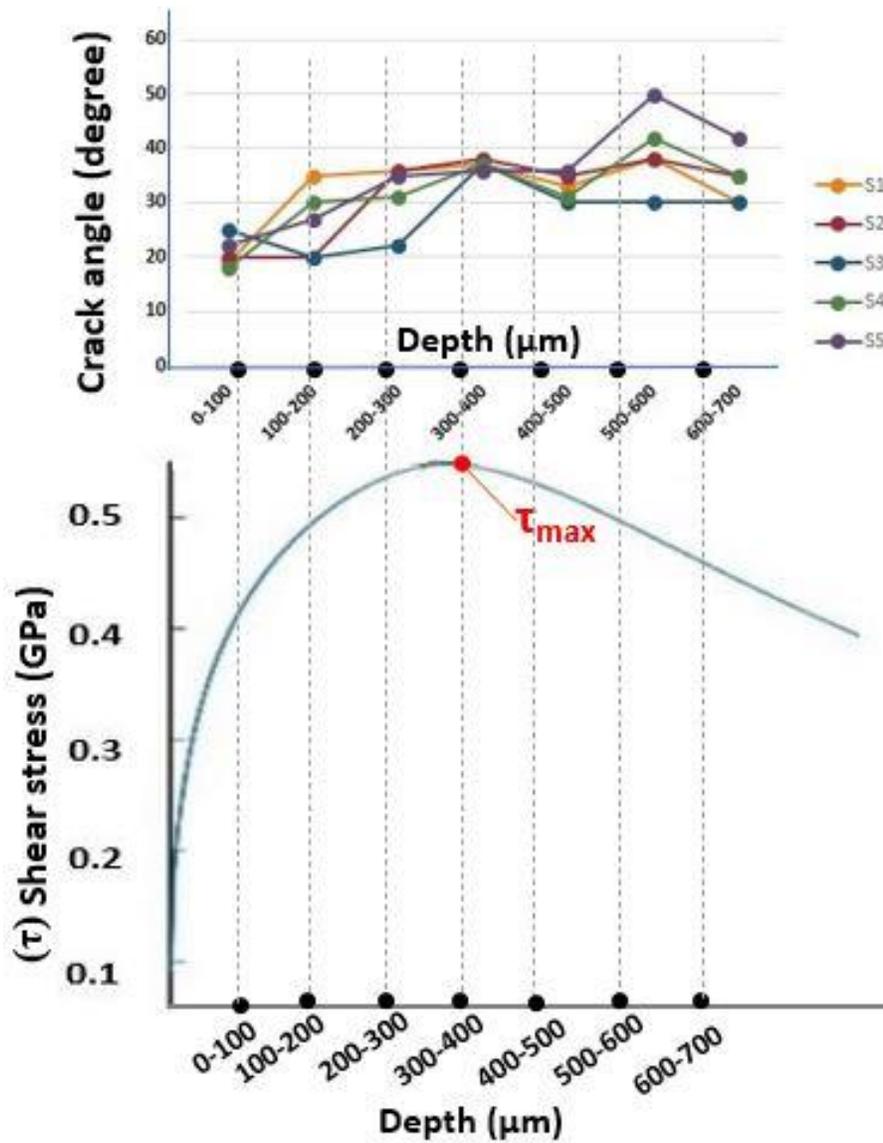
Figure 4-21: Correlation of cracks' inclination angles with depth for the investigated samples (top) and distribution of shear stress with depth (down) [247]

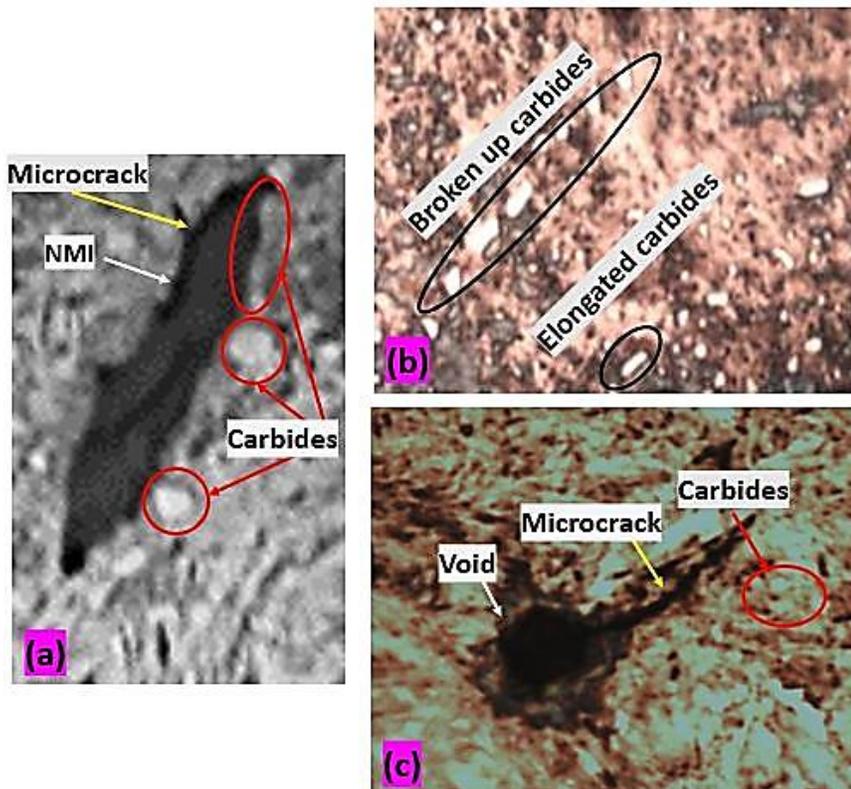
Figure 4-23: The behaviour of carbides and voids as microstructural alteration triggers [the researcher]

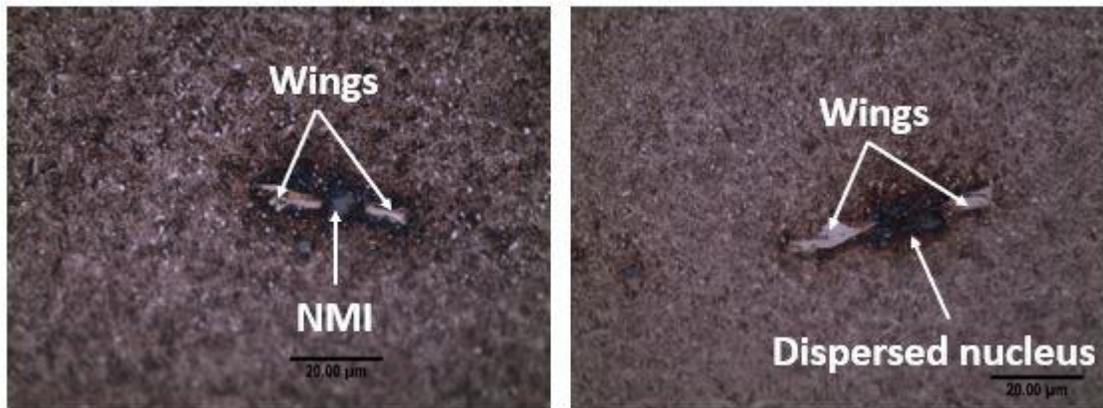
Figure 4-24: Butterfly feature (a) with a central NMI, (b) with a dispersed nucleus [the researcher]

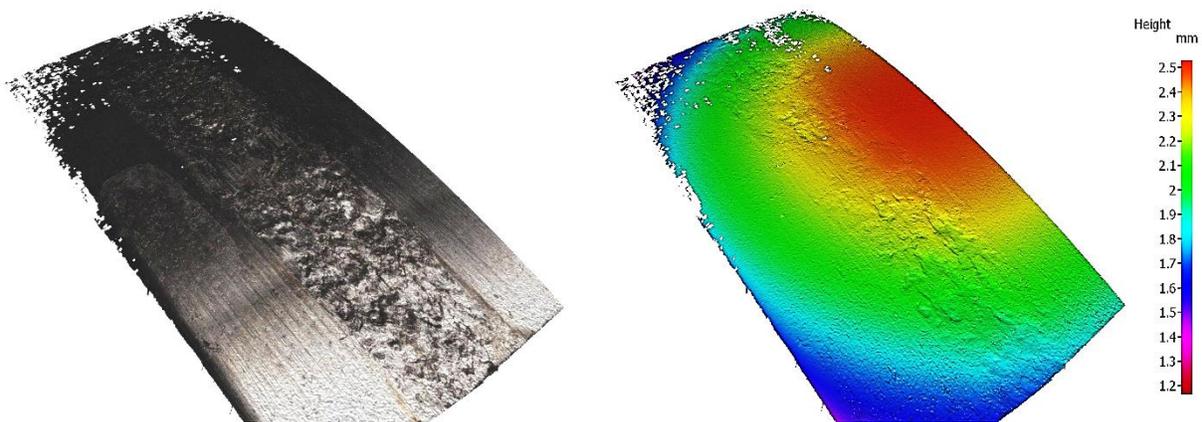
Figure 4-25: Surface damage analysing using Alicona analyser [the researcher]

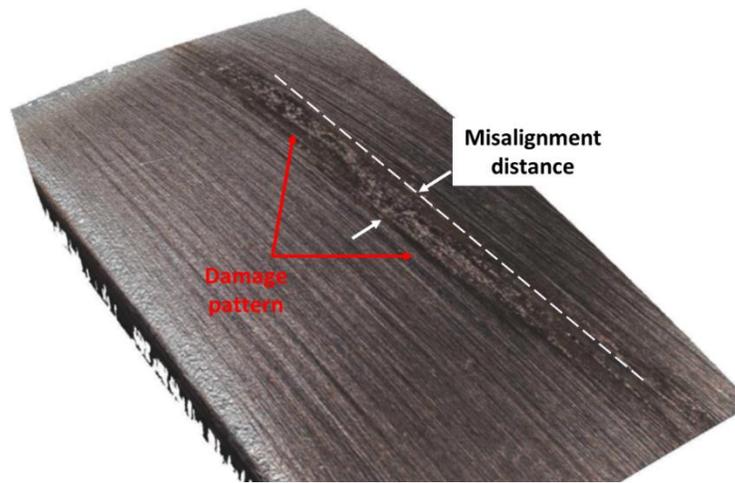
Figure 4-26: Surface damage initiation pattern [the researcher]

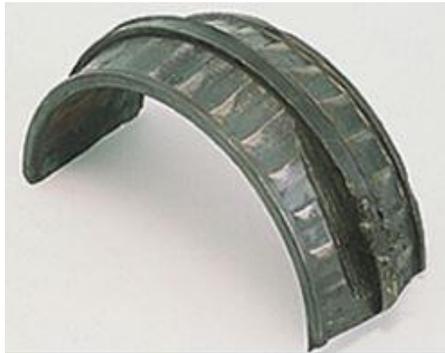
-Inner ring of double row tapered roller bearing,
-Seizing up discolors and softening the inner ring producing stepped wear at a spacing equal to distances between the rollers,
-The cause is poor lubrication.

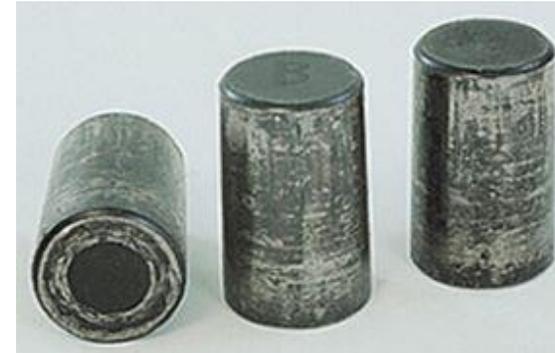
-Rollers of double row tapered roller bearing,
-Rollers of the same bearing as that of the inner ring. Discoloration, spalling, and adhesion due to seizing up on rolling contact surfaces and end faces of rollers.

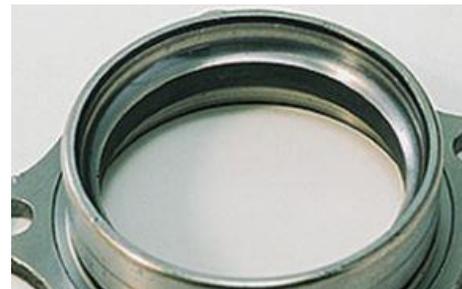
-Outer ring of double row angular contact ball bearing (hub unit bearing),
 -Wear on one side of the raceway,
 -The cause is poor lubrication.

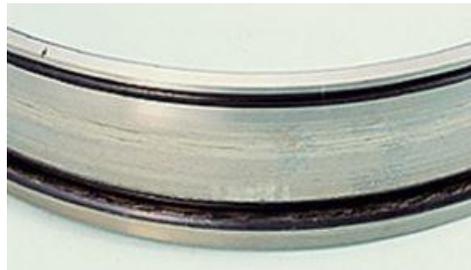
-The inner ring of the cylindrical roller bearing,
 -Spalling on raceway surface and cone back face rib,
 -The cause is poor lubrication.

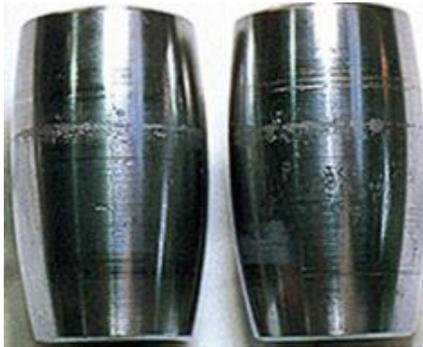
-Rollers of spherical roller bearing,
 -Peeling on rolling contact surfaces,
 -The cause is poor lubrication.

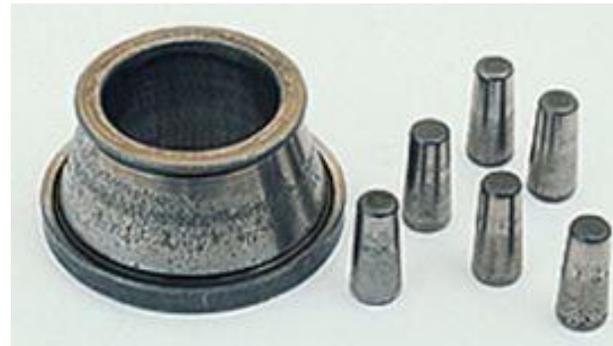
-Tapered roller bearing,
 -Development of peeling to flaking on inner ring and rollers,
 -The cause is poor lubrication.
